SEDCO 702 MODU

Repair of Vessel Impact Damage to the Sedco 702 Modu, 1999

Replacement of Chain Locker on the Sedco 702 Modu, 1999

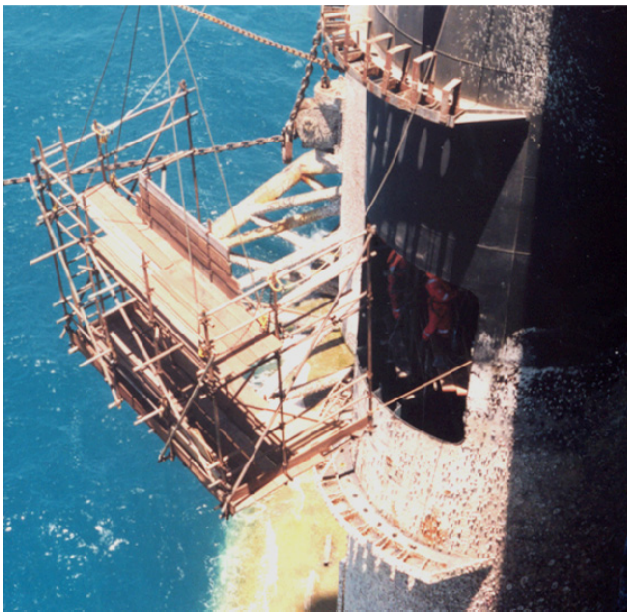
Lifting the prefabricated scaffold into place

The work required a patch approximately 4m square to be cut from the column and replaced with a prefabricated patch. A key feature of the work was the prefabricated scaffold which was assembled onshore and brought out in a single piece. This allowed work to be carried out on the opening immediately the damaged shell section had been cut away. The scaffold was designed to allow the new patch to be lowered into place between the scaffold and the column.

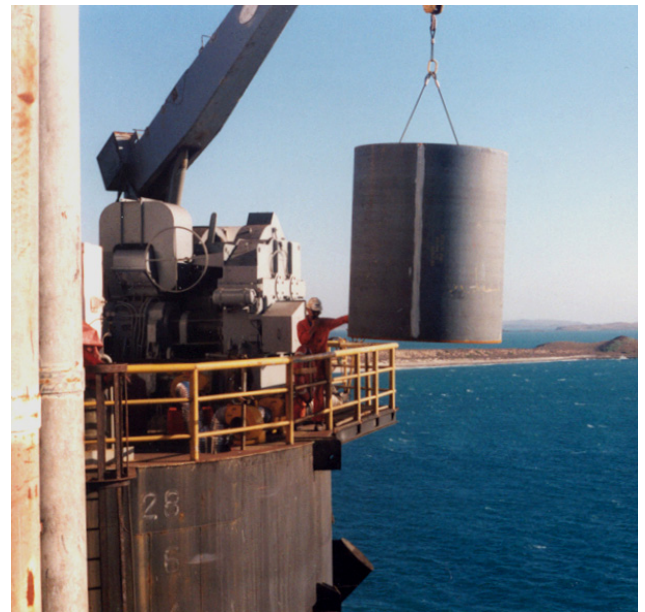
Lifting a section of the chain locker through the deck opening

A key feature of the job was the planning to allow for the removal of the old sections and installation of the new sections within the highly stiffened column. This required access hatches to be cut and a transfer system to be set up to allow the sections to be moved in and out of the chain locker.
