Seadrill - West Atlas (MODU) Pre-load Tank Side Plate Hull repairs

ICON was contracted to Project Manage the Class (ABS) specified repairs to both tanks.

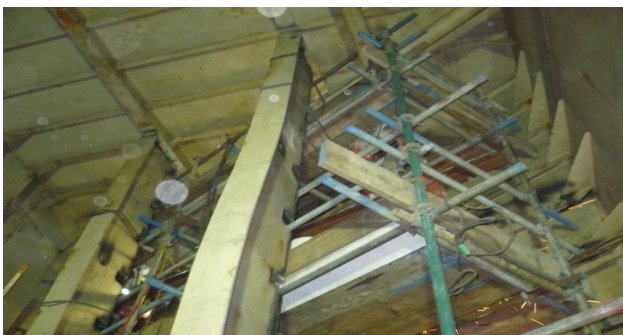
Extensive in-tank scaffolding required.

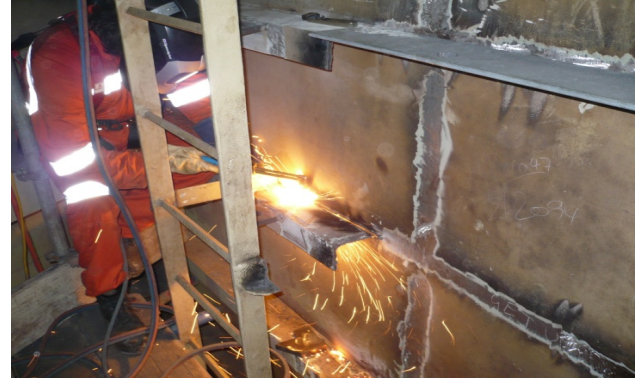
Gas Arc cutting the frames free from the side plate.
